Technical

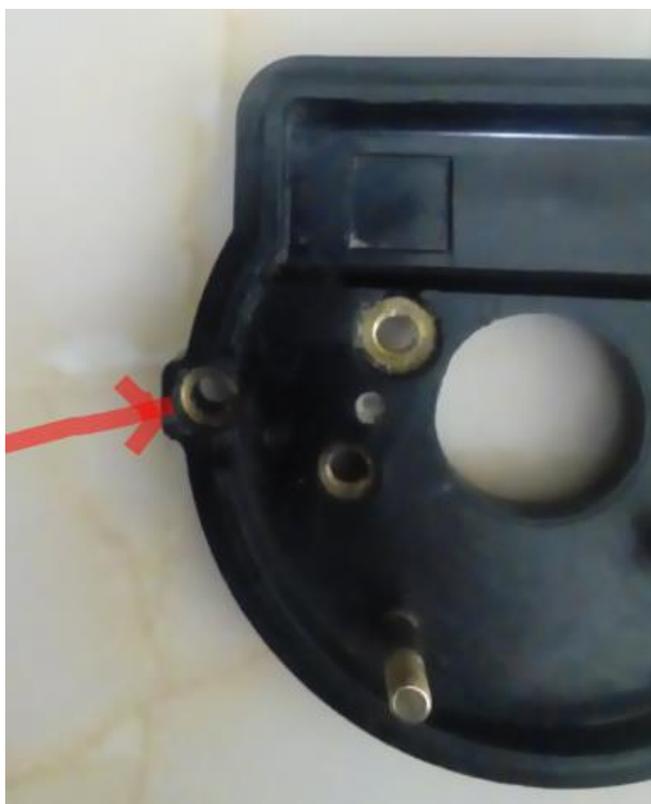
The problem was cured by changing the Bakelite base plate, so what causes it to fail, on closely examining the base plate, I noticed the left hand position for one of the securing setscrews had a brass washer cast into the Bakelite (see photograph) the securing setscrew tightens down onto this brass washer.

On investigating further I found that the brass washer is part of the earthing system that is laminated into the baseplate, this system supplies the earth return for the condenser and C/B points (see photograph) if there is a break in this system it is impossible for the distributor to function normally.

The brass washer indicated by the arrow is the return earth pick up point, this in turn is laminated via the Bakelite base plate to supply a earth return to the Condenser and C/B points.

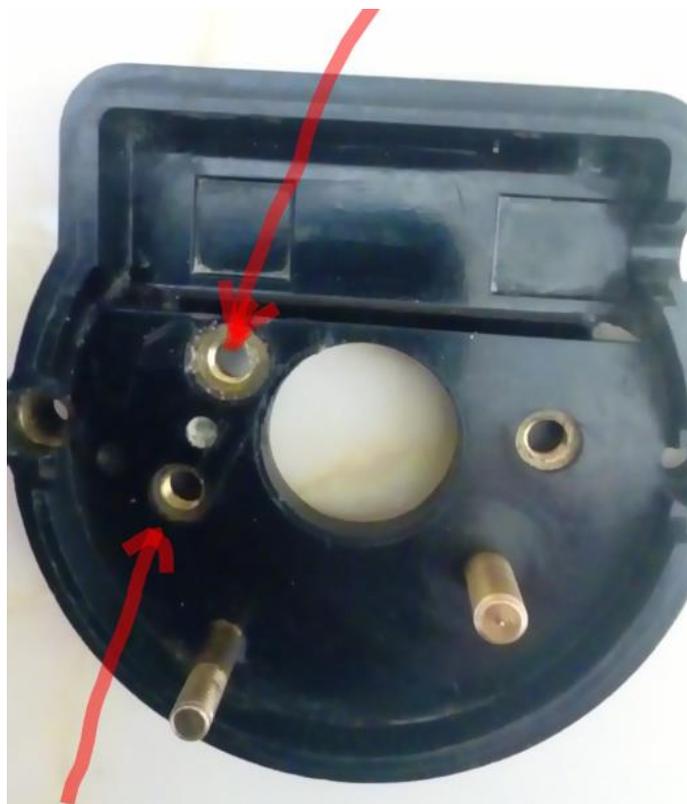
The two arrows indicate the earth return points for the Condenser and C/B, also they indicate where a temporary earth feed can be attached.

So what can be done if this happens on the road miles from anywhere and you don't carry a spare baseplate, the temporary get you home answer is rig an emergency earth by using a very thin section of insulated wire between one of setscrews on the base plate and then onto to a clean earth point, if the wire is thin enough , it will pass under the distributor cap. You could use either of the two setscrews illustrated in the photograph to supply the emergency earth.
