## Fuel Pump

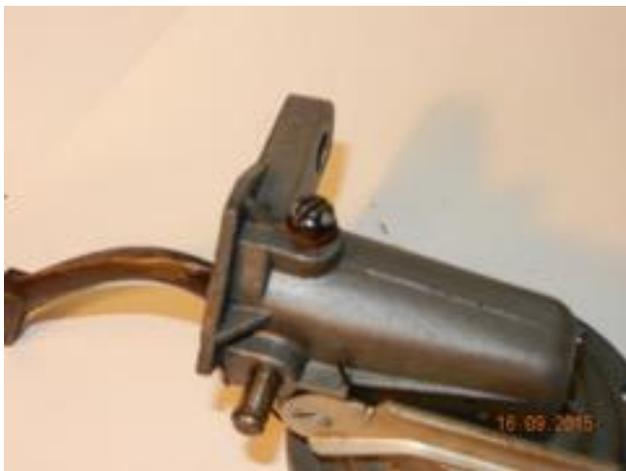
Fig A1

The problem therefore seemed to lie with the pump. On comparing the damaged pump from which the replacement return spring had been salvaged (Photos A1 and A2) with my pump (Photo B) it could be seen that the damaged pump had a small screw with a stud turned on the end of it inserted at the bottom of the pump and this served

as a stop controlling the movement of the rocker arm. This meant that in pump

A the rocker arm would be unlikely to go the wrong side of the camshaft whereas in pump B gravity meant that as soon as the pump was offered up to the camshaft the rocker arm would drop down and it would be very difficult or impossible to insert the pump with the rocker arm on the correct side of the camshaft. This would not apply if the engine is turned on its side or is upside down. In the Austin factory, the pump was probably fitted into the engine on the bench and so the problem was not noticed, I suspect that it was only realised that a problem existed when reports from Austin dealers came back to the factory. Then, of course, Austin must have told AC to solve the problem and hence the screw/stud was fitted to all later pumps.
