Replacing the Differential Case Gasket.

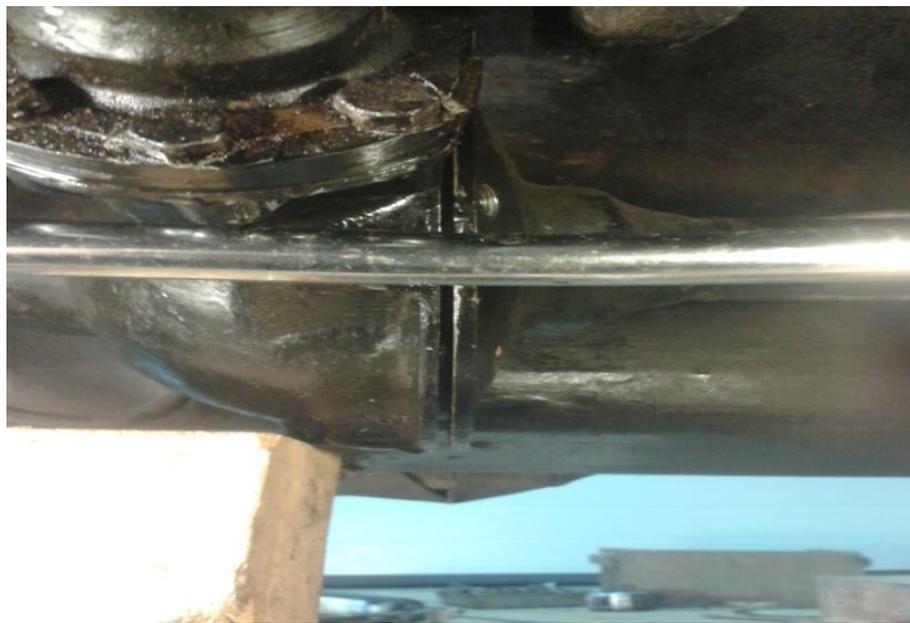
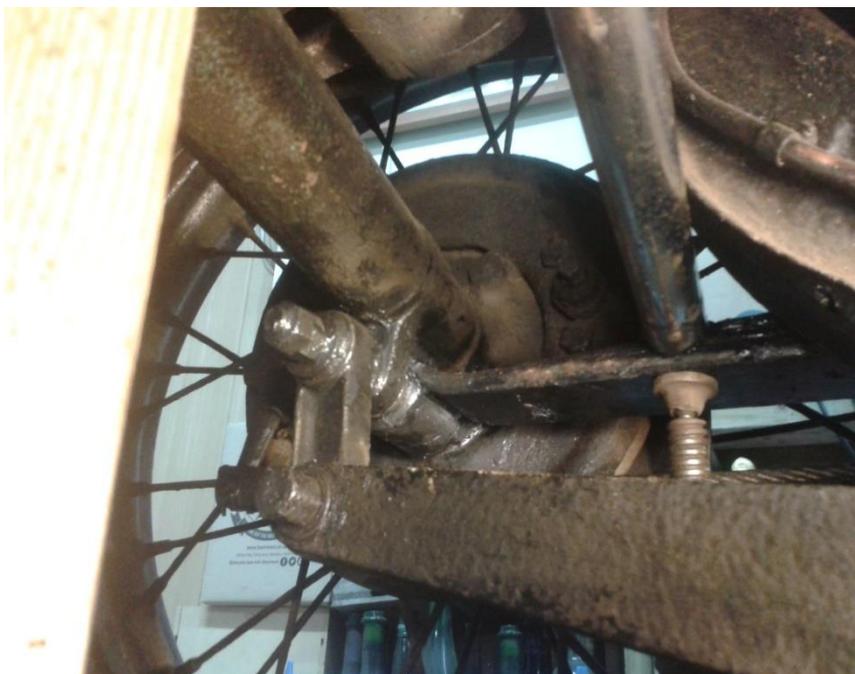
The total distance between the bottom of each slot in the tube was $\frac{1}{8}$ " longer than the distance between the springs. This would allow for some compression of the copper and move the two parts of the Diff. housing apart about $\frac{1}{16}$ ". The tube was then gently tapped into position using a rubber mallet. This then allowed the existing gasket to be removed by using a round ended knife (to be washed and returned secretly to the kitchen drawer after use). The gasket had broken into six pieces and had been so, for some time. Without the gasket in place the space was amply big enough to clean both of the surfaces ready to receive the new gasket, this can be seen in the second photograph.

In order to get the new gasket fitted, it had to be cut at the most uppermost point so that it could be fed into position. This was equi-distant between two of the bolt holes and the cut positioned at 12 o'clock to reduce the chance of a leak. I usually use Loctite 5980 gasket sealer, a black silicone looking compound available in tubes, but being unable to obtain any, I used silicone sealant which I have found in the past a good substitute; apologies to all the purists who have just winced at that. I then proceeded to replace the six bolts but not

tightening them until the copper tube had been removed. The bolts were then finally tightened in the usual diagonal fashion and the tab washers duly tapped back in position. 'G' clamps and blocks removed, I waited to refill the back axle until the following day, to ensure that everything had set to reduce the chance of leaks. At the time of writing, I have done a few miles since the new gasket was fitted but have been unable to go on long runs due to the current restrictions surrounding Covid 19. There are no visible signs of leakage on the newspaper that is waiting to show the slightest sign below the differential. I hope that I did put the new oil in!
