Camshaft pulley removal

Nearly all Austin Seven owners at some time find it necessary to remove the camshaft fan pulley, usually to change a leaky felt seal between the pulley and the nosecone.

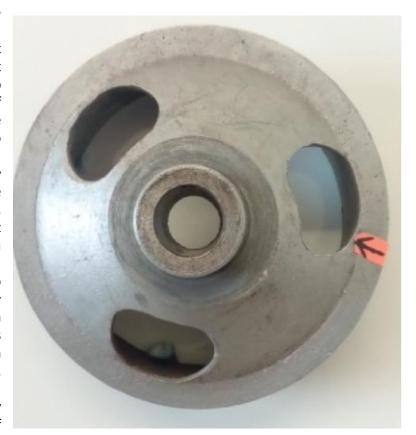
- If the engine is in-situ, it is a good idea to protect the radiator honeycomb core by taping a piece of stout cardboard to the inside of the radiator to protect it
- 2. Remove the pulley securing nut and take off the lock washer, then replace the nut leaving a gap between the nut and pulley
- 3. Do not attempt to remove the pulley axially by the use of a puller or extractor, this will probably result in removing just the rim, leaving the boss behind
- 4. Observe that the pulley effectively consists of

three wide 'spokes' connecting the rim to the boss. Then using a drift made of alloy, hardwood or hard nylon, apply blows (in a direction that is parallel to the face of the pulley) to the area where the 'spokes' meet the rim – downwards is easiest, as if you were trying to rotate the pulley on the camshaft

This should free the pulley but if difficulties continue, try turning the engine to rotate the camshaft through 120° in order to attack the next spoke etc. It is also permitted to apply gentle heat to the central area of the pulley
