## Choke Cable replacement.

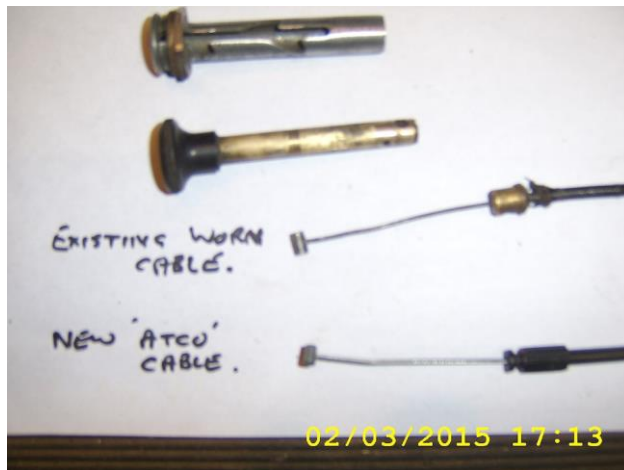
The Choke Cable in my Opal was badly worn, kinked and frayed (like many of us .... Ed) and there was no doubt a replacement was required as both the Inner and Outer were damaged.

It is critical that the nipple end is a good fit in the choke control lever. My efforts to source a new cable were not successful, so I tried the local bike and motorbike shops. Having met with no success there, I tried the local garden machinery service centre. The nipple size and shape for an ATCO Motor Mower is exactly the same as my 1937 Opal. The only difference being the outer cable having a different diameter on the end to be used next to

the choke control. This can be seen in the photograph showing the two cables side by side.

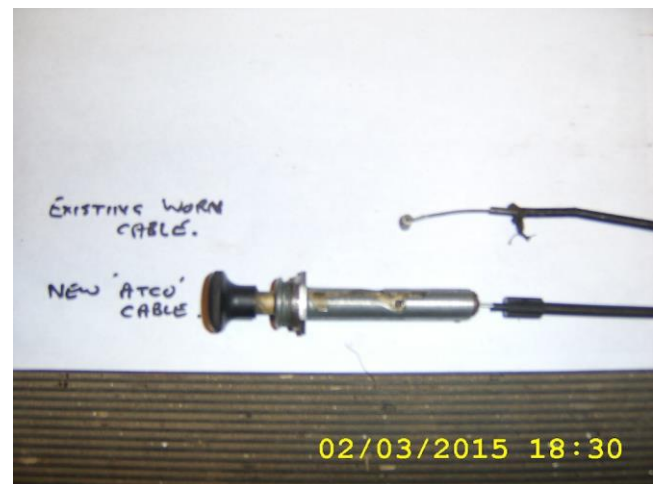
The assembled items can be seen in the second photograph. All that remained was to cut the cable to length, being considerably shorter than that required for an ATCO Mower!

I cut off the end of the new cable at the carburettor fixing, so that I could remove the Inner. I was then able to turn down the plastic end cap to be inserted into the choke control lever, which then replicated the original Bowden cable used in 1937. The inner was then replaced and the whole lot assembled into the choke control, the nipple being exactly the same as the original.
